Marlin Crawler MC09
4.7 low range gears
 Tacoma/4Runner - 2.7 liter 26 spline

Fresno, California
May 12, 2003

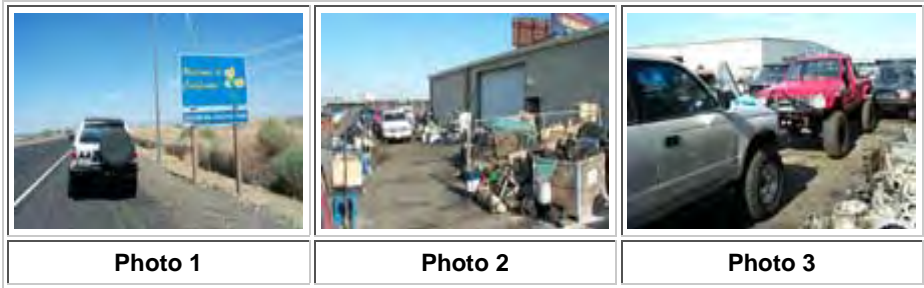
Photo 1 Photo 2 Photo 3

Photo 1: Entering California.
 Photo 2: The Marlin Crawler shop.
 Photo 3: My 1999 4Runner and Marlin's 1983 pickup.

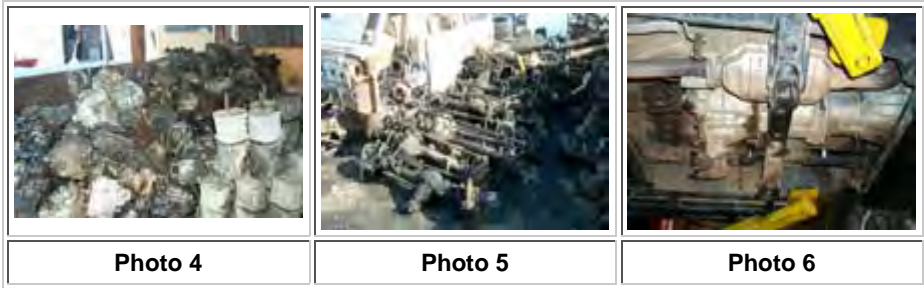
Photo 4 Photo 5 Photo 6

Photo 4: Pile of Toyota transfer cases & transmissions.
 Photo 5: Pile of 1979-1985 Toyota front axles.
 Photo 6: Stock transmission and transfer case.

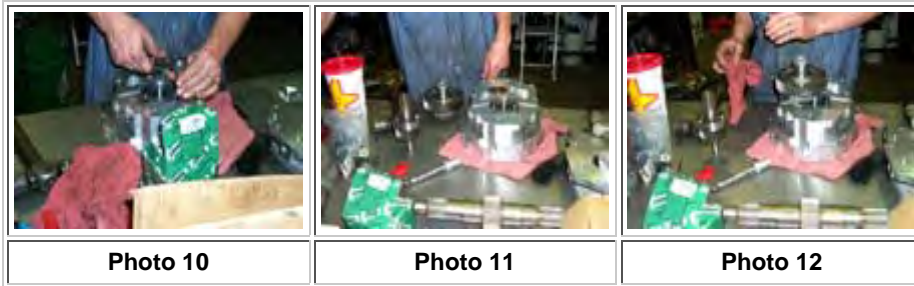
Photo 10: Building the MC09 crawler.

Photo 11: Building the MC09 crawler.

Photo 12: Building the MC09 crawler.

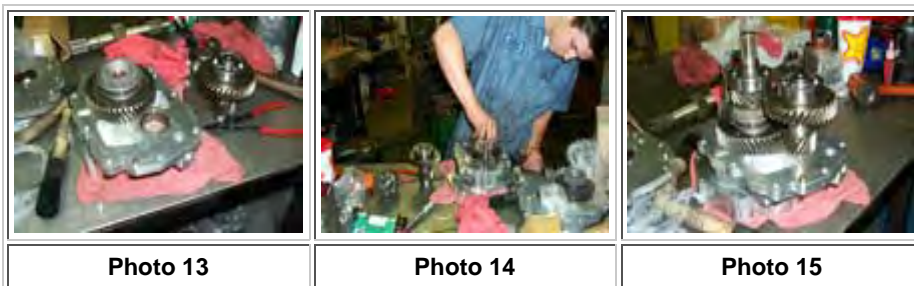
Photo 13: Building the MC09 crawler.

Photo 14: Building the MC09 crawler.

Photo 15: Building the MC09 crawler.

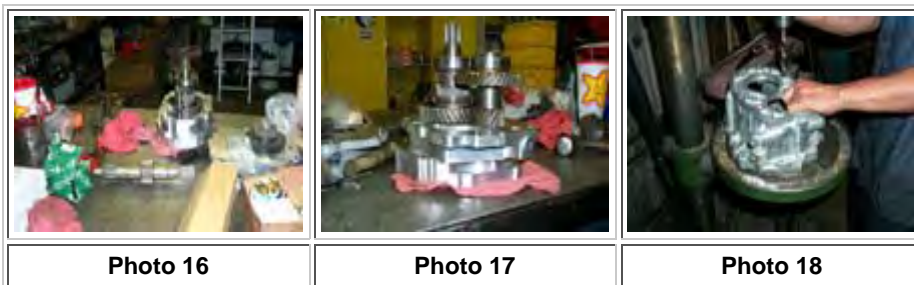
Photo 16: Building the MC09 crawler.

Photo 17: MC09 with 4.7 Japanese made gears.

Photo 18: Beginning to work on the gear driven case housing.

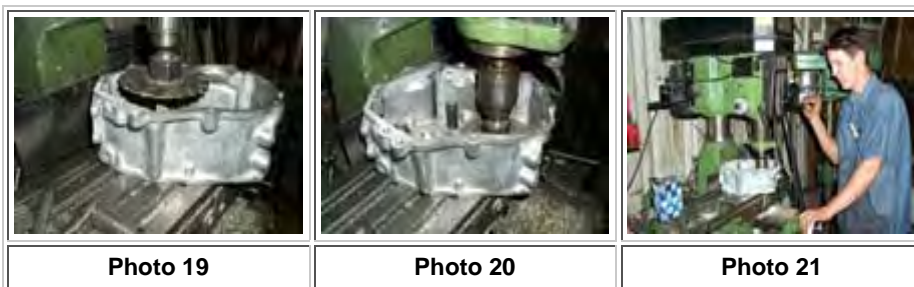
Photo 19: Clearanceing the gear driven case for the 4.7 gears.

Photo 20: Clearanceing the gear driven case for the 4.7 gears.

Photo 21: Clearanceing the gear driven case for the 4.7 gears.

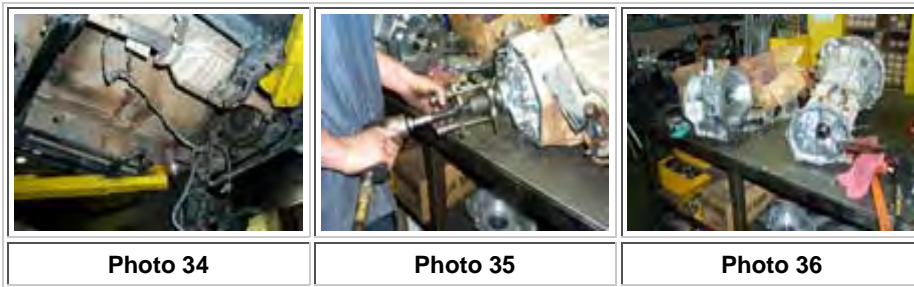
Photo 34

Photo 34: Transmission and transfer case removed.

Photo 35: Pulling 26 to 26 spline coupler which will be replaced with a 26 to 23 spline coupler.

Photo 36: 5-Speed ready for the crawler to be installed.

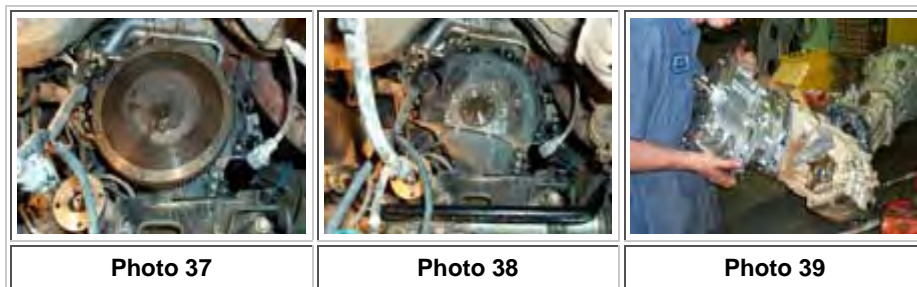
Photo 37

Photo 37: Clutch flywheel, you can see where I burned it wheeling.

Photo 38: Flywheel removed.

Photo 39: Assembling the crawler / transfer case / transmission.

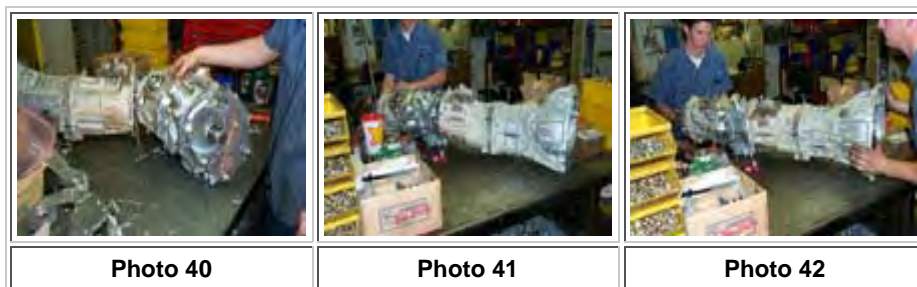
Photo 40

Photo 40: Assembling the crawler / transfer case / transmission.

Photo 41: Assembling the crawler / transfer case / transmission.

Photo 42: Assembling the crawler / transfer case / transmission.

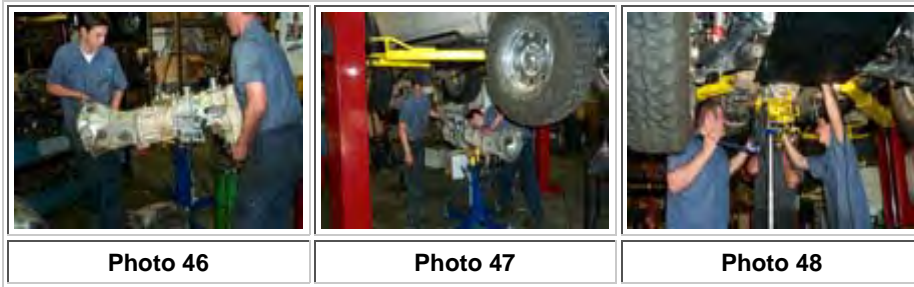
**Photo 46****Photo 47****Photo 48**

Photo 46: Completed transmission / crawler / transfer case.

Photo 47: Lifting the unit up into the truck.

Photo 48: Lifting the unit up into the truck.

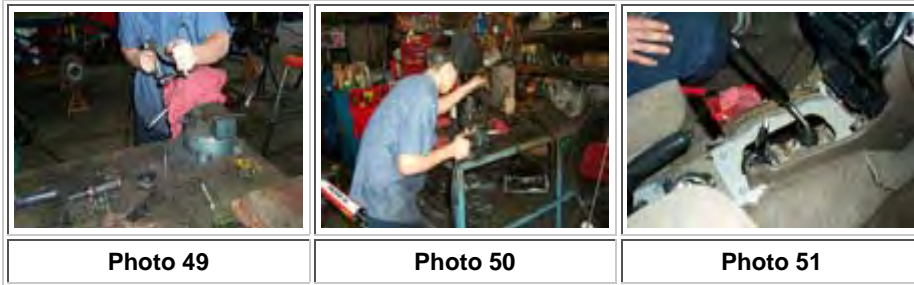
**Photo 49****Photo 50****Photo 51**

Photo 49: Starting the custom shift levers by cutting a stock lever into 3 pieces. Converting to short throw as well.

Photo 50: Welding the shift lever back together with the short throw bottom.

Photo 51: Custom lever installed in the 4Runner.

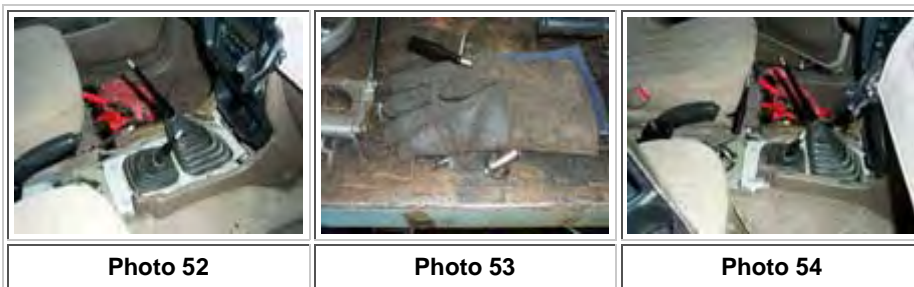
**Photo 52****Photo 53****Photo 54**

Photo 52: Front boot re-installed.

Photo 53: Three parts to the shift lever. Tooth, ball and lever.

Photo 54: Rear lever installed in the 4Runner.

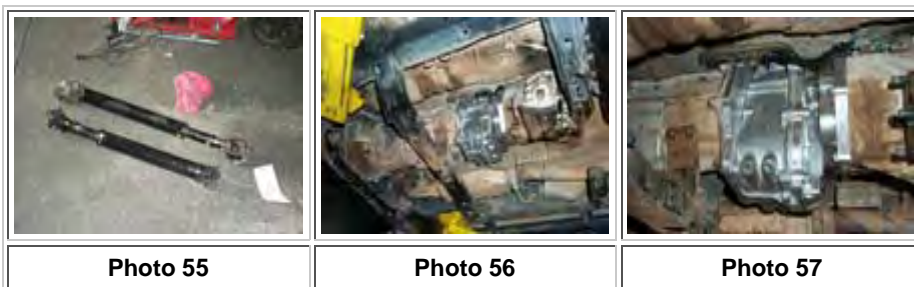
**Photo 55****Photo 56****Photo 57**

Photo 55: Drive shafts after being lengthened and shortened.

Photo 56: Transmission / MC09 crawler / Transfer case installed in the 4Runner.

Photo 57: MC09 crawler, the serial numbers can be seen.

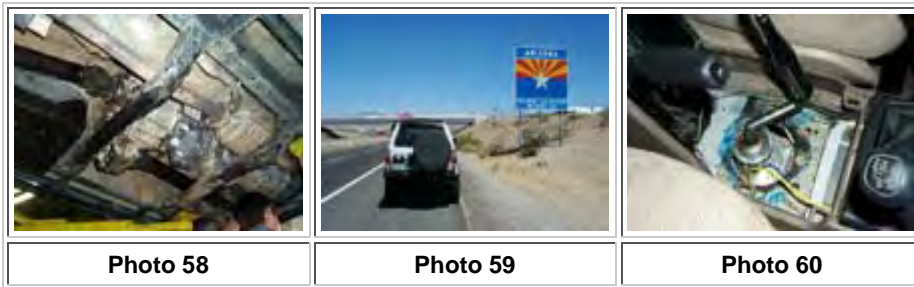
Photo 58

Photo 58: Crawler installed in the 4Runner.

Photo 60: On the drive home the shifter bases rubbed the body so I got the dremel out and cleaned up the openings.

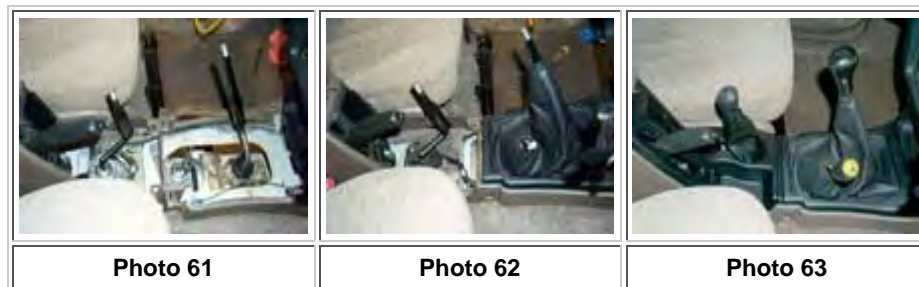
Photo 61

Photo 61: Shifter holes after being dremeled looser back in Arizona.

Photo 62: Front boots re-installed.

Photo 63: The 3 levers: 5-speed, crawler box with 4.7 gears & stock transfer case. The rear cup holder & brake handle was retained in the stock location.

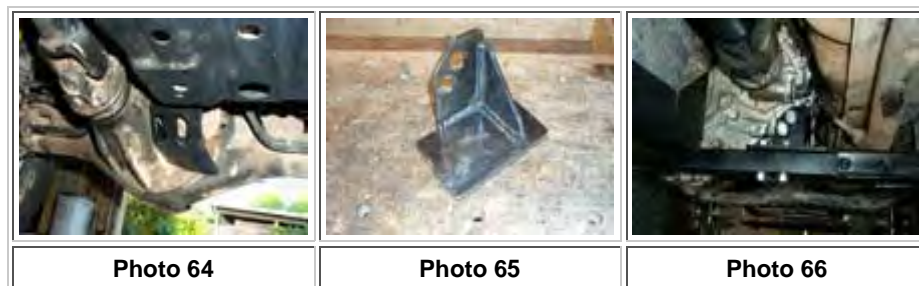
Photo 64

Photo 64: Marlin has a few R.O.R.E. e-locker skid plates, so I picked one up as an impulse purchase and installed it when I got back to Arizona.

Photo 65: Rear support bracket I made for the transfer case. The longer assemble was hitting the body with the shorter drive shaft and the extra length.

Photo 66: Rear support installed with Daystar poly shock bushings for dampening.

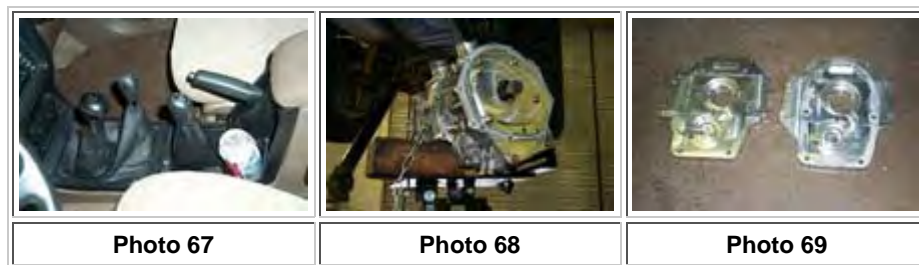
Photo 67

Photo 67: Final interior shift levers. Two stock transfer case knobs looked the cleanest to me.

Photo 68: In January of 2004 the Crawler box was removed to swap the front adapter plates.

Photo 69: The front plate Marlin installed in Fresno was apparently machined incorrectly so they shipped me a redesigned front adapter plate. The crawler box was burping gear oil out the shifter base.

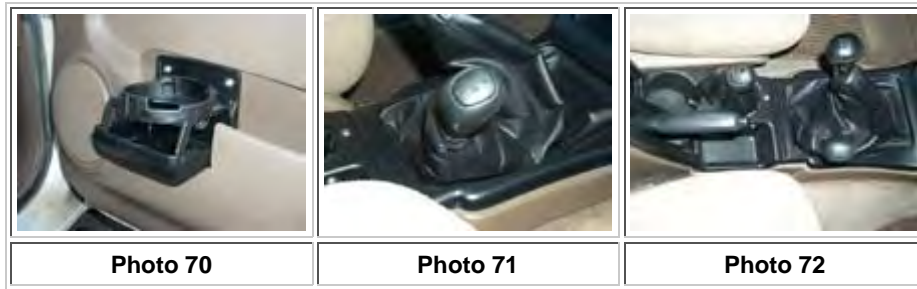
Photo 70

Photo 71: I found an original Toyota OEM 4WD shift lever knob with the actual shift pattern of the crawler box. This knob is from a 4WD 2003 Toyota Sequoia, Toyota Part # 36303-34030.

Photo 72: The three genuine Toyota shift knobs, all showing the actual shift patterns of the levers.

I also installed a 1" Body Lift from Roger Brown to create more clearance for the levers under the center counsel and for the relocated stock case under the body. This is needed to prevent the Tacoma style transfer case from hitting the bottom of the body.
