Marlin Crawler MC09

4.7 low range gears

Tacoma/4Runner - 2.7 liter 26 spline

Fresno, California
May 12, 2003

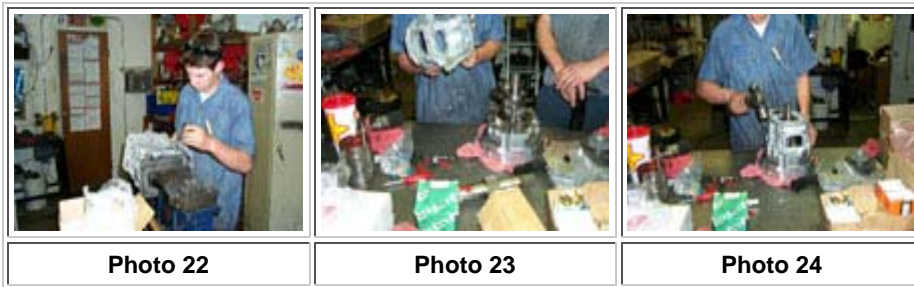
Photo 22: Punching in the serial numbers.

Photo 23: Ready to assemble the gear driven cover.

Photo 24: Adding the cover to the 4.7 gears.

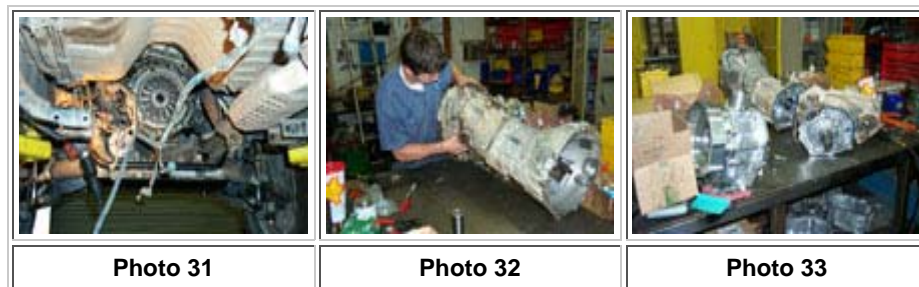
Photo 31: Transmission removed clutch visible.

Photo 32: Separating 5-Speed transmission from the transfer case.

Photo 33: MC09 Crawler, Stock Transfer case and 5-Speed transmission.

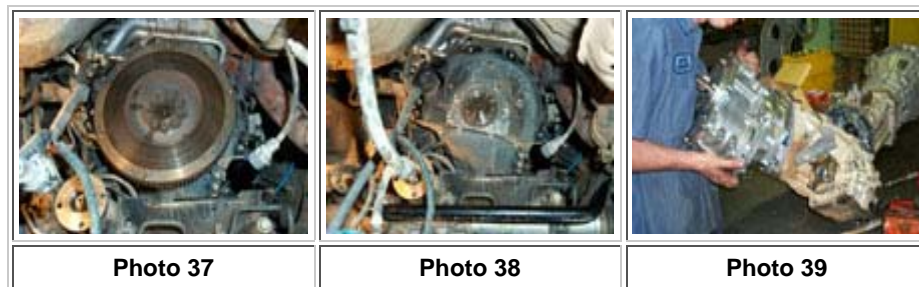
Photo 37: Clutch flywheel, you can see where I burned it wheeling.

Photo 38: Flywheel removed.

Photo 39: Assembling the crawler / transfer case / transmission.

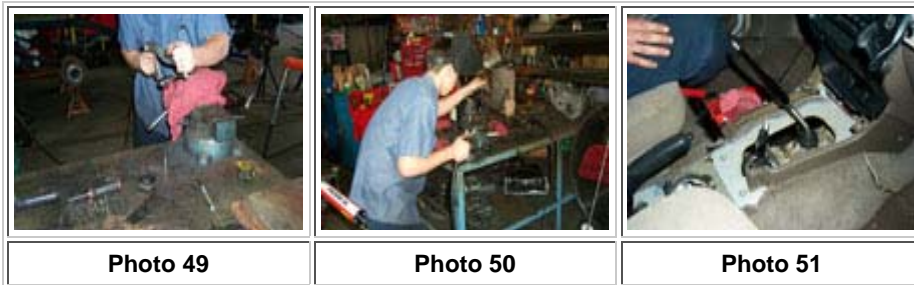
Photo 49: Starting the custom shift levers by cutting a stock lever into 3 pieces. Converting to short throw as well.

Photo 50: Welding the shift lever back together with the short throw bottom.

Photo 51: Custom lever installed in the 4Runner.

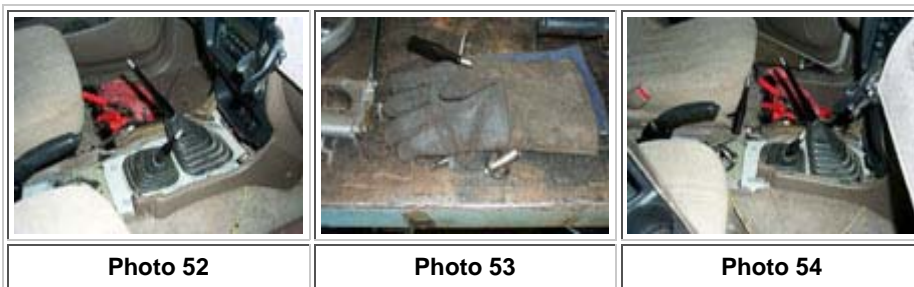
Photo 52: Front boot re-installed.

Photo 53: Three parts to the shift lever. Tooth, ball and lever.

Photo 54: Rear lever installed in the 4Runner.

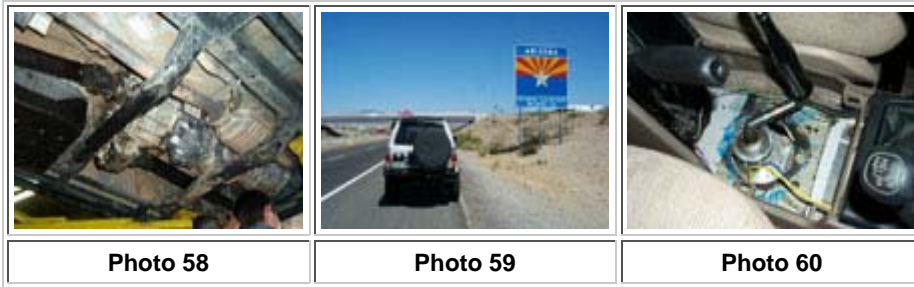
Photo 58: Crawler installed in the 4Runner.

Photo 60: On the drive home the shifter bases rubbed the body so I got the dremel out and cleaned up the openings.

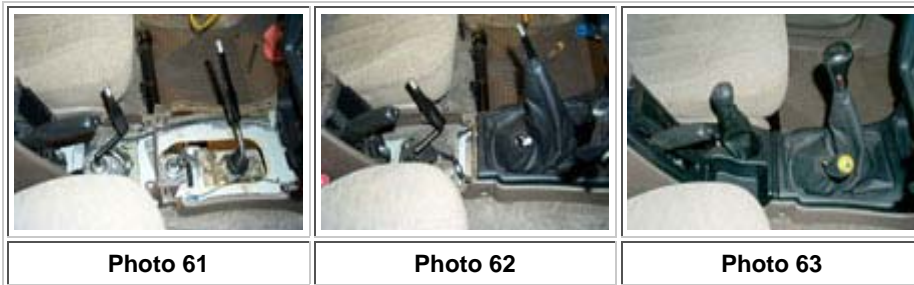
Photo 61: Shifter holes after being dremeled looser back in Arizona.

Photo 62: Front boots re-installed.

Photo 63: The 3 levers: 5-speed, crawler box with 4.7 gears & stock transfer case. The rear cup holder & brake handle was retained in the stock location.

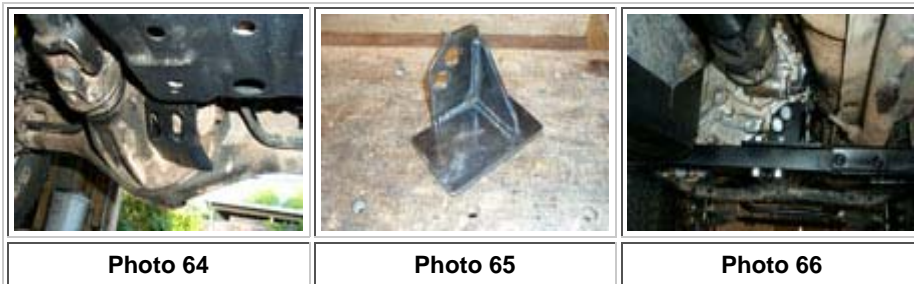
Photo 64: Marlin has a few R.O.R.E. e-locker skid plates, so I picked one up as an impulse purchase and installed it when I got back to Arizona.

Photo 65: Rear support bracket I made for the transfer case. The longer assemble was hitting the body with the shorter drive shaft and the extra length.

Photo 66: Rear support installed with Daystar poly shock bushings for dampening.

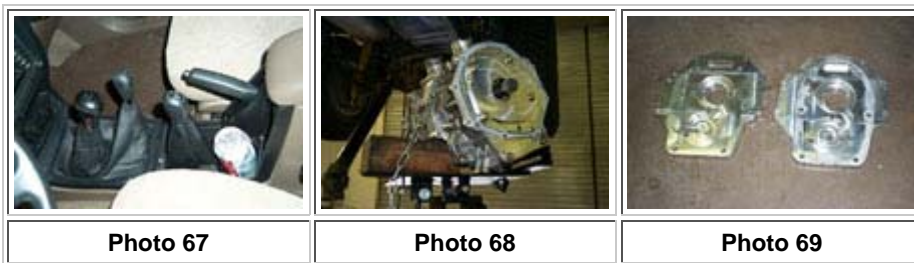
Photo 67: Final interior shift levers. Two stock transfer case knobs looked the cleanest to me.

Photo 68: In January of 2004 the Crawler box was removed to swap the front adapter plates.

Photo 69: The front plate Marlin installed in Fresno was apparently machined incorrectly so they shipped me a redesigned front adapter plate. The crawler box was burping gear oil out the shifter base.
